**Designing healthy and accessible
urban environments with older
people in mind**

Detailed Design

What are the key attributes of detailed design (at both the street scale and neighbourhood scale) likely to influence aspects of older people's quality of life?

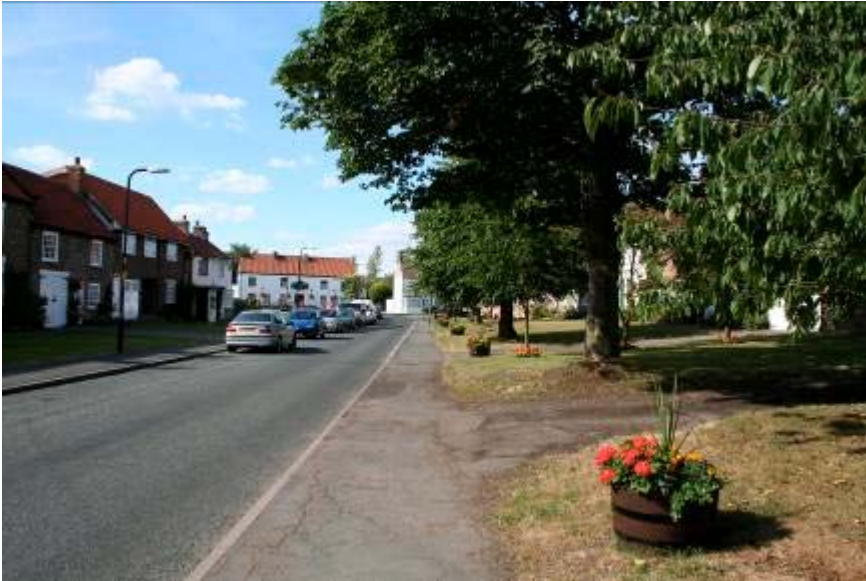
Wide and flat tarmac footways

- Can avoid street furniture and pedestrians
- Feel safe from traffic
- Tarmac seen as smooth, even, non slippery, safer from tripping, comfortable to walk on
- Should be well maintained
- Need distinguished path for cyclists

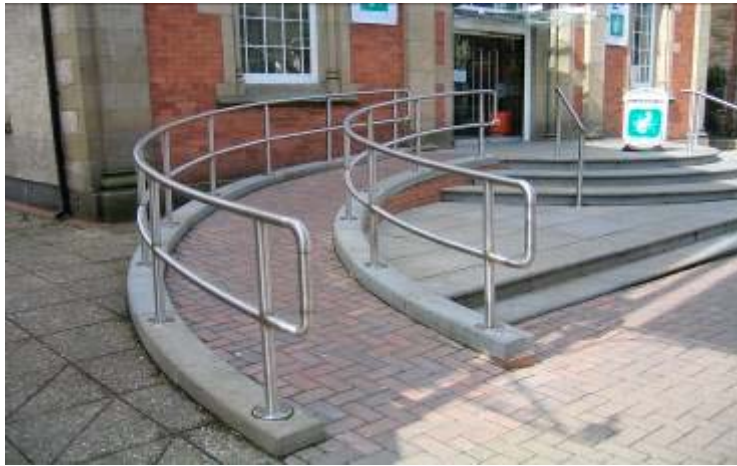
Easy transition at level changes (1)

- Ramps with handrails to be used for level changes (issues of ease and safety)

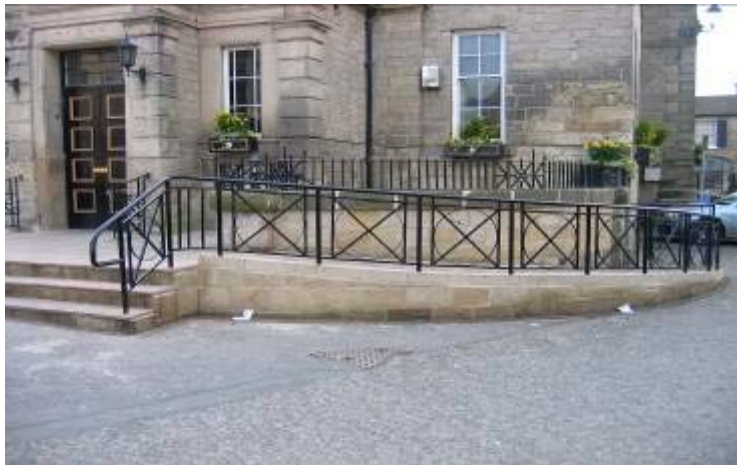
- Steps and handrails as an alternative for those who want the exercise

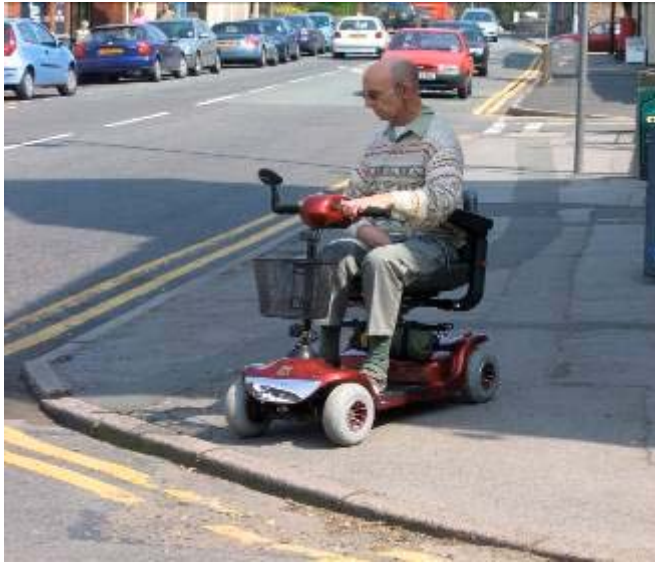
Easy transition at level changes (2)

- Provision of dropped kerb important

- Narrow footways (either through design or obstacles)
- Generally smooth paving (+ve navigation) but 28% paving was poor / dangerous due to lack of maintenance
- Poor ease of movement because of siting of obstacles
- Lack of dropped kerbs at road crossing points
- Incorrectly laid / poorly laid tactile paving
- Uncontrolled road crossing points
- Limited bus stop / shelter / seat provision
- Very limited seating along routes (rather than destination)
- Easy to read and understand signage (+ve wayfinding)

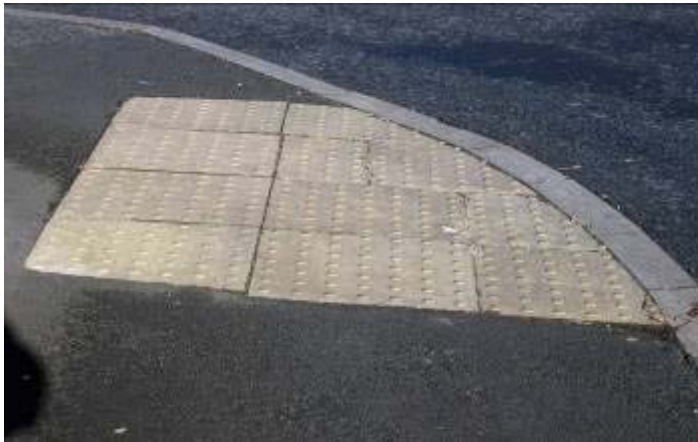
- Tactile dropped kerb needs further investigation

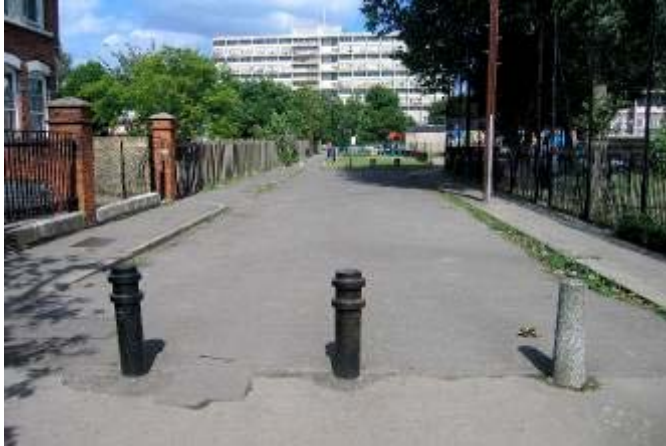
Unobstructed walkways (1)

- Permanent obstructions inconvenient but necessary

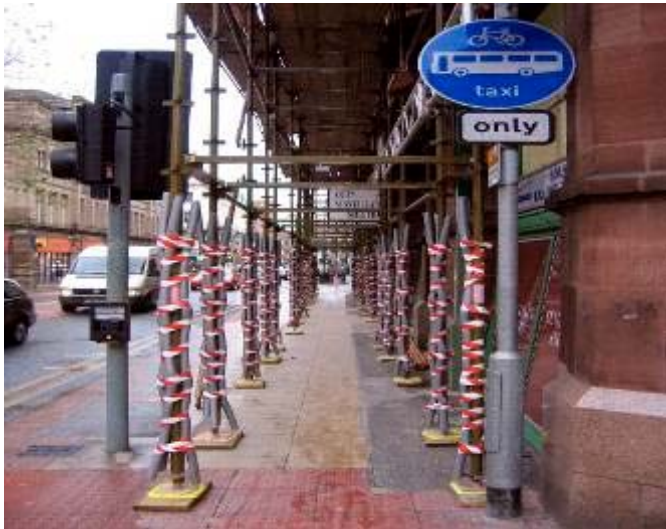
- Temporary obstructions are tolerated

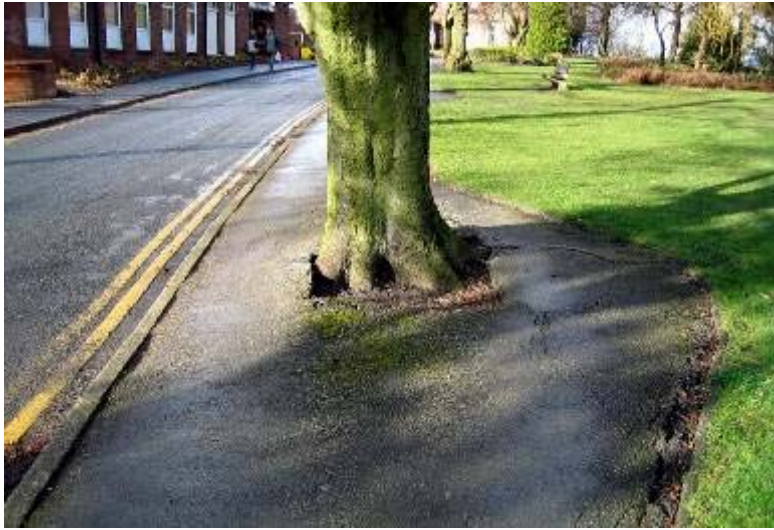
Unobstructed walkways (2)

- Obstructions from poorly maintained paving seen as hazardous

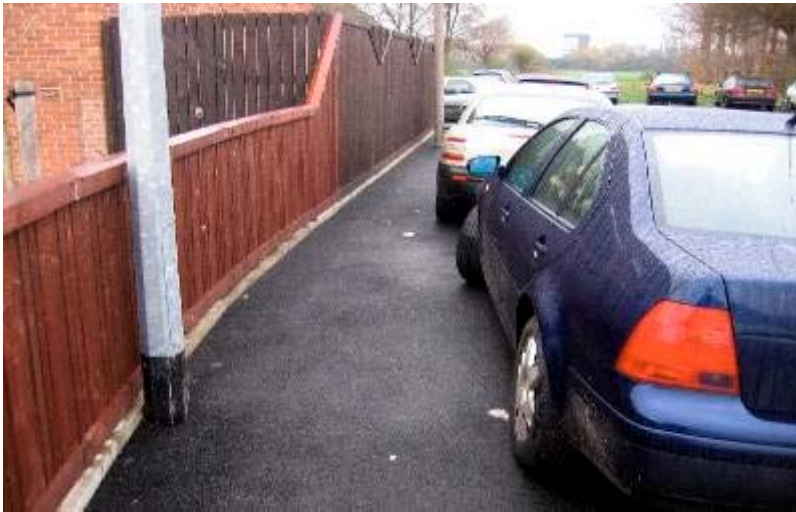
- Cars parked on pavement are major problem

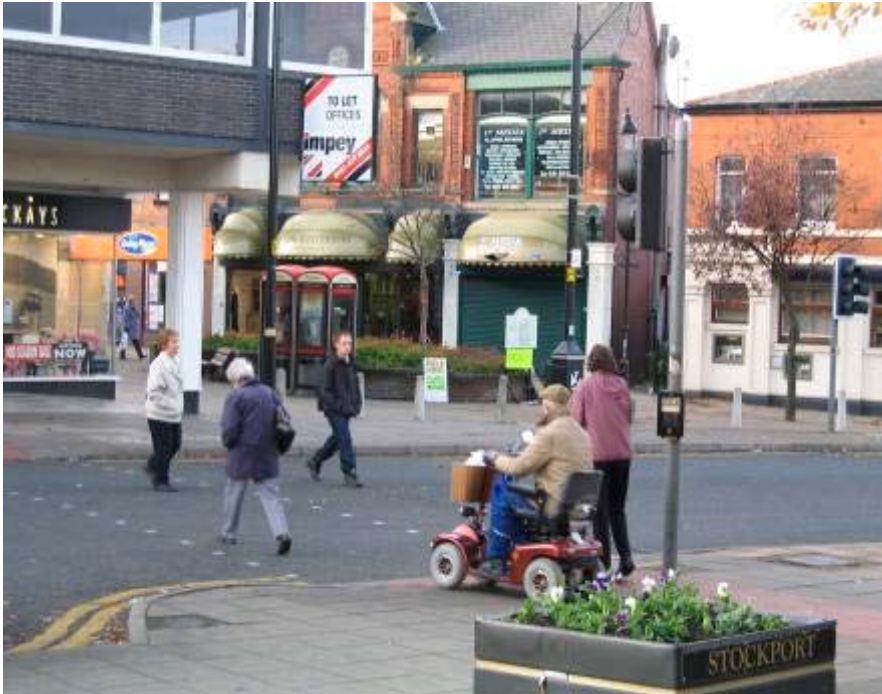
Controlled crossing points

- Pelican crossings preferred (ease of use and safety)
- Audible signal to be provided
- Short crossing distance important

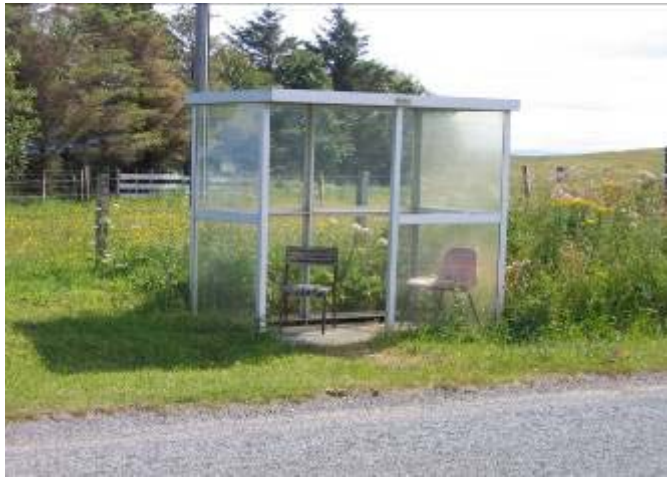
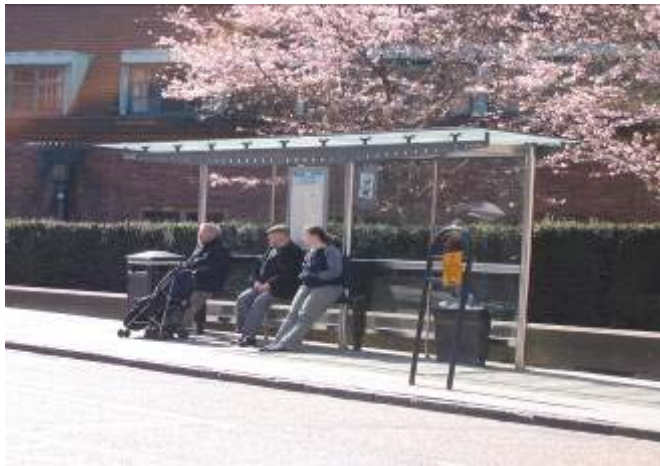
Bus stops and shelters

- Provision
- Weather protection
- Seating
- Personal safety
- Seeing the bus

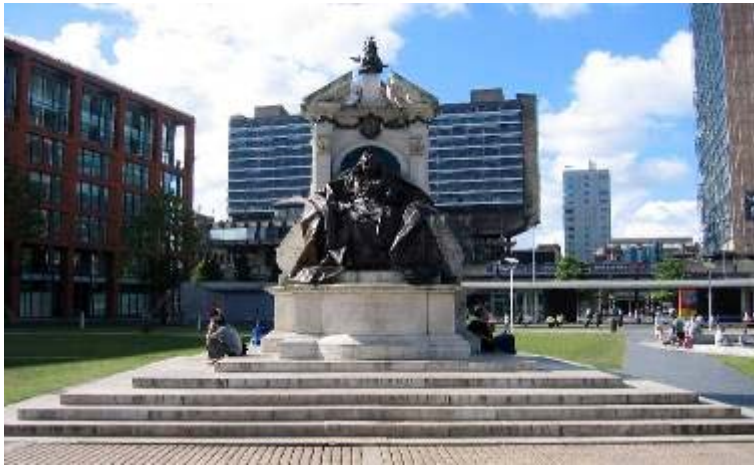
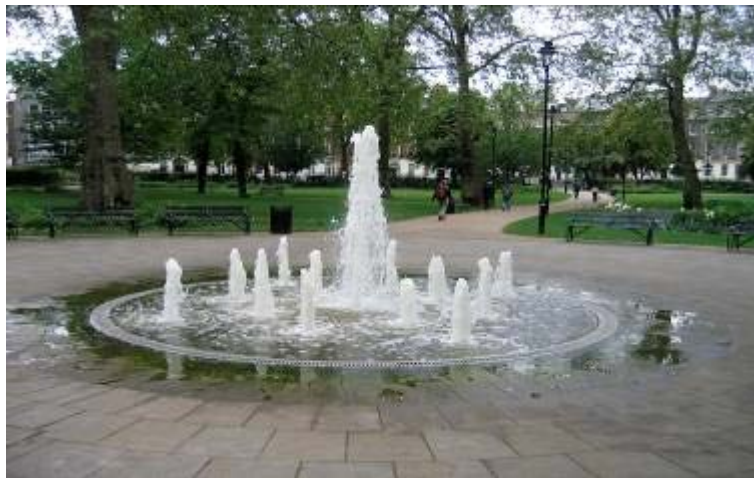
Easily maintained public art

- Classical public art is preferable to modern
- Water features are seen as very enjoyable
- Graffiti is not seen as art but as nuisance
